# Development of a Polymetric Grout for the Hydrostatic Bearing at DSS 14

C. E. McClung, J. L. Schwendeman, G. L. Ball III, and G. H. Jenkins  
Monsanto Research Corporation

*The grout under the hydrostatic bearing runner at DSS 14 has exhibited a rapid rate of deterioration and premature failure. This report examines some of the probable causes of the deterioration. It also describes the development of a polymetric grout that is more resistive to the causes of early grout failure.*

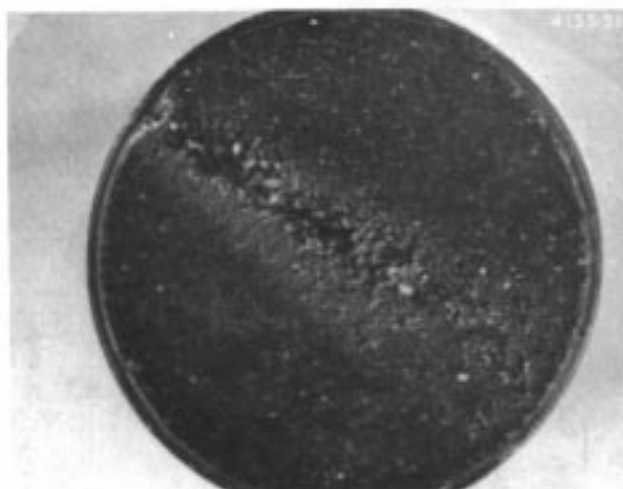
- (a) A WATER-CORRECTED DRY-PACK GROUT SURFACE AFTER 15,500 CYCLES SHOWS ONLY MINOR SURFACE PITTING. THE DAMAGED AREAS APPEAR TO BE SUPERFICIAL AND ISOLATED WITH NO EROSION CHANNELS.

- (b) THE DRY-PACK GROUT WITH PACKING INTERFACE, NOW WATER-CORRECTED AND EXPOSED TO OIL AFTER 8 h, SIMULATING PROBABLE REAL CONDITIONS, SHOWS SEVERE EROSION DAMAGE AFTER 5,700 CYCLES.

- (c) AFTER 13,700 CYCLES, THE DRY PACKING INTERFACE IS 12.7 mm OR DEEPER AND THE CHANNEL WIDTH HAS UNDERGONE SIMILAR WIDENING. OTHER AREAS OF THE SURFACE HOWEVER, ARE NOT SERIOUSLY DAMAGED.

**Fig. 6. While water-corrected grout appears highly durable to erosive effects, its vulnerability to water loss is clearly seen**

The portland cement dry-pack grout, shown in Fig. 6a after 15,500 cycles, shows only minor damage by erosion. Some minor pitting and erosion was seen near the outside rim of the specimen and mostly around the exit port area, which is the area of greatest volume movement. The pitting is shallow, and in most cases, single, small aggregate particles were lost from the outer surface. No deep channels or structural damage was seen. It is not believed that erosion to this limited extent would adversely affect the antenna operation.

Most importantly, this sample was monitored for evaporative water loss during mixing, and the water content was corrected (to w/c = 0.23) just before placement. Figures 6b and 6c show the results of placing and packing the test surface in two increments, such that a packing interface was created parallel to the direction of oil flow. Here the water lost during mixing was not replaced, and the test surface was exposed to oil after 8 hours cure. The total cure time before start of the

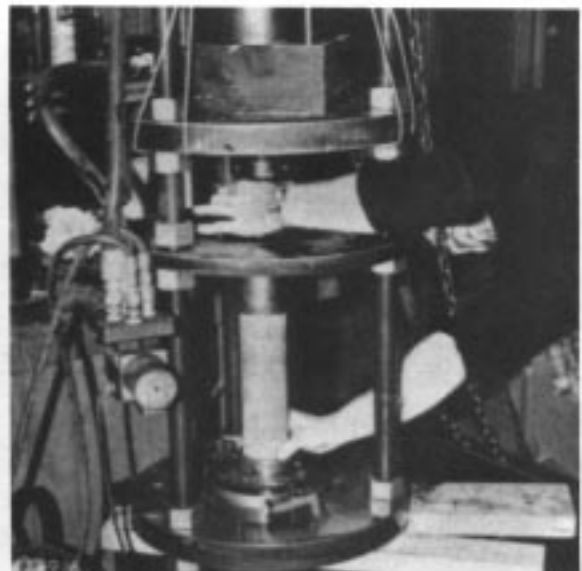
Fig. 12. The piston and sleeve are carefully aligned and the stroke length set so that the piston contacts and exerts full pressure on the cylinder surface in each cycle

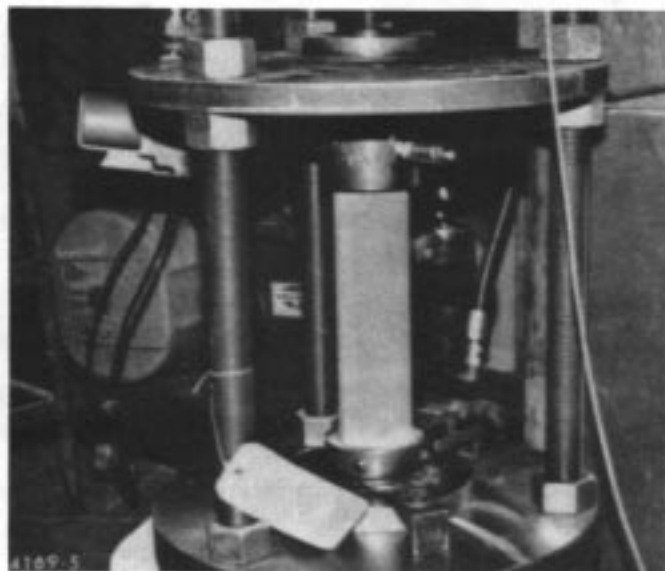
Fig. 11. After inserting the piston into the oil chamber sleeve, the assembly is locked in position by retaining rings top and bottom

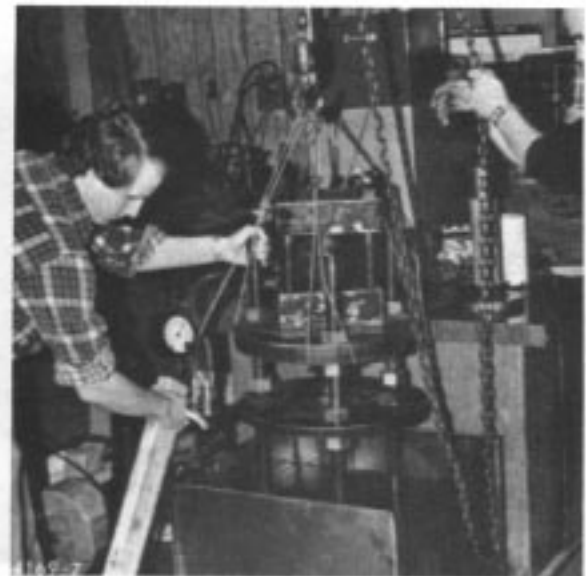
Fig. 13. After final checks, the apparatus is lowered into the oil reservoir

Figure 13 also shows the details of the method adopted to hold down the top plates. During the emplacement and curing of the grout, it was learned that the method was not entirely satisfactory. The thermal expansion of the grout caused a very slight lifting or bowing of the angle iron. As a consequence, more deflection of the steel cover plates was observed adjacent to the hold downs than was observed along the center line of the plates.

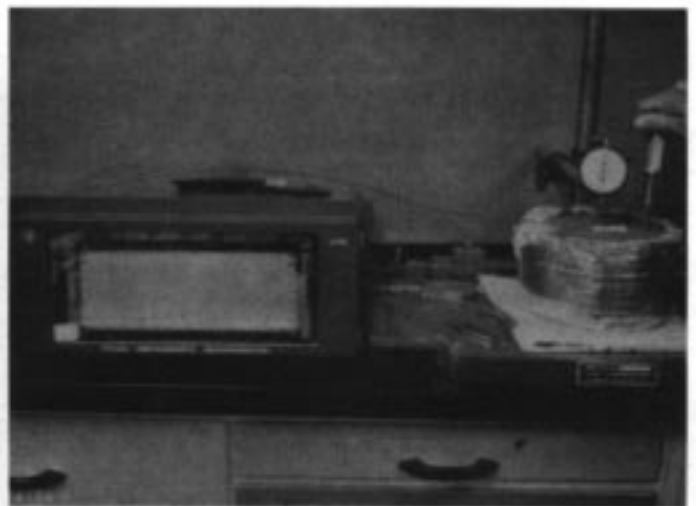
Fig. 16. Apparatus for testing the curing characteristics of aggregate/resin grouts

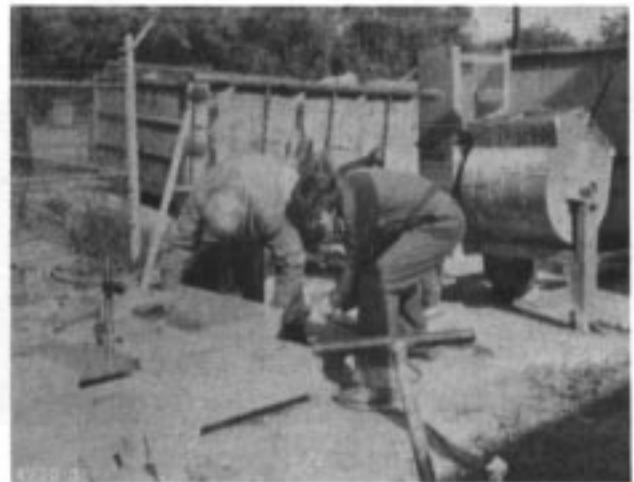
Fig. 20. Loading 48-cm  $\times$  48-cm  $\times$  15-cm cavity with epoxy grout

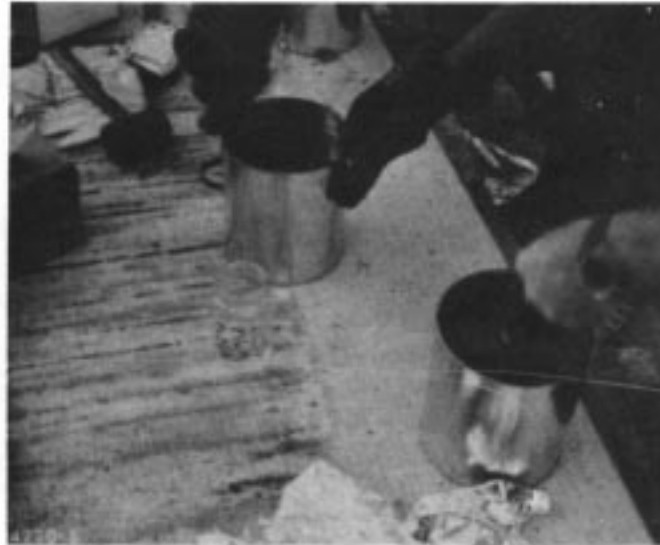
Fig. 23. Hand mixing of epoxy-TETA resin in 3.785-liter cans
